# QUALICHECK

## A Greek study on quality of works, compliance with existing legislation and EPC data

# Greek New Study Collection

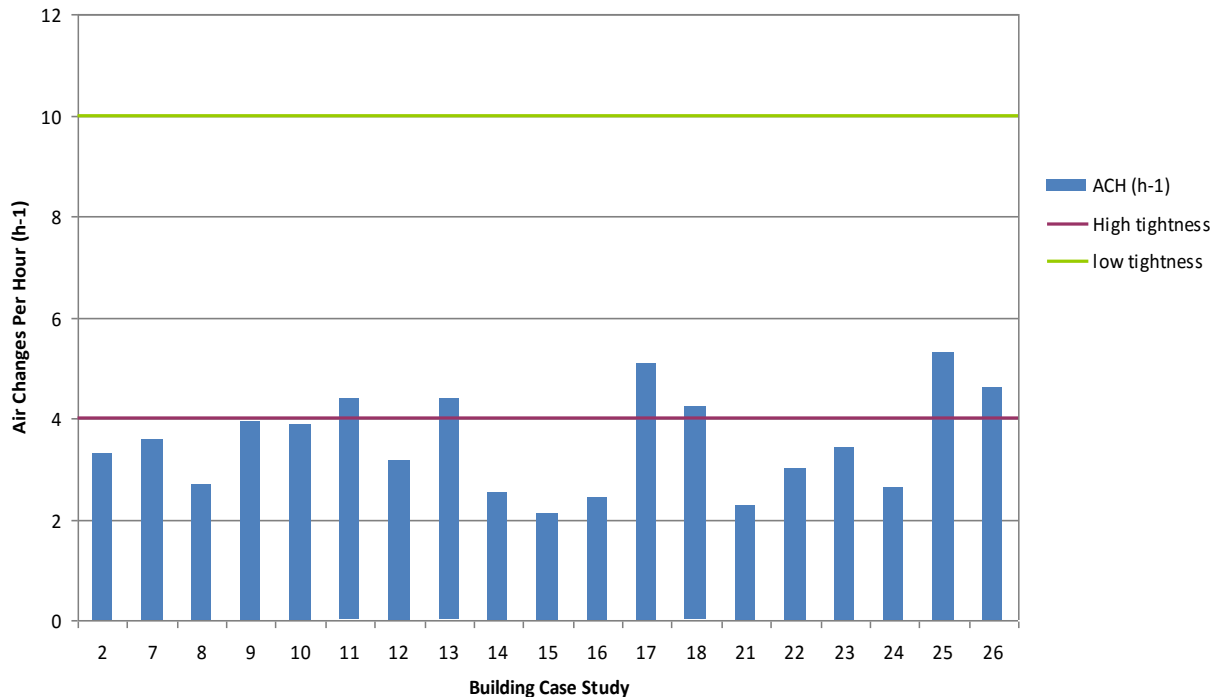
## Air tightness

The majority of the buildings (68%) that were examined has ACH values lower 4 and that shows a high level of envelope air tightness

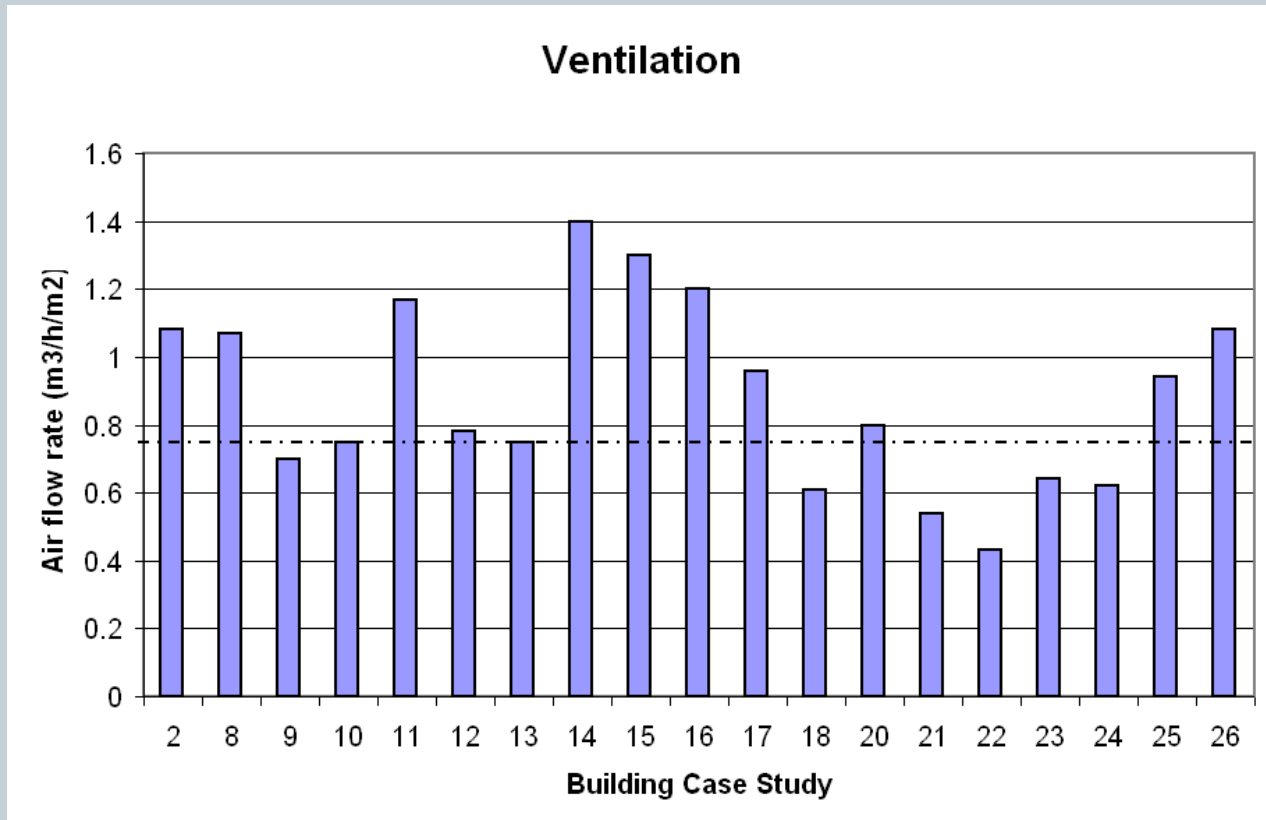
Air flow for single and multi family buildings compared to the reference value of  $0.75\text{m}^3/\text{h}/\text{m}^2$  (Technical Chamber of Greece Directive TOTEE 20701/2010)

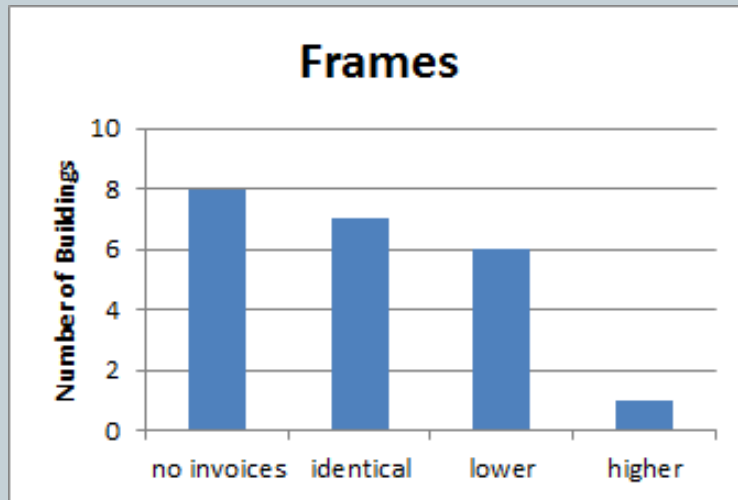
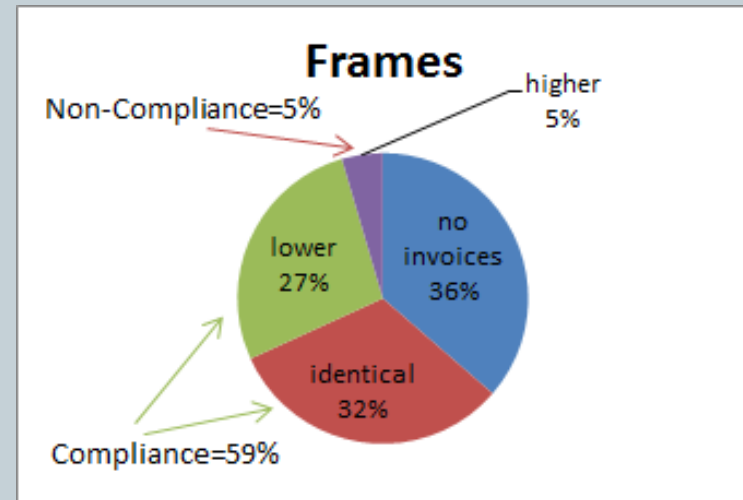
Comparison of the materials' implementation values as reported in the final EPC with the design values

Implementation values higher than the design	Implementation values lower than the design
Range of difference for frames U-values	25%	0.6-35%

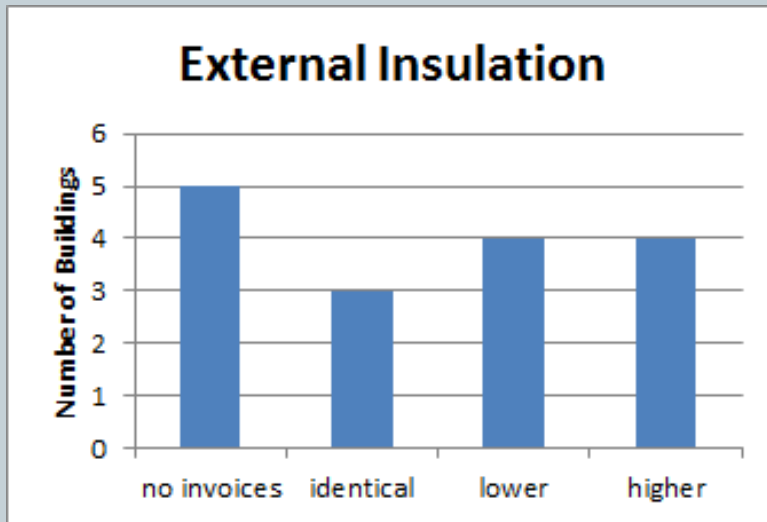
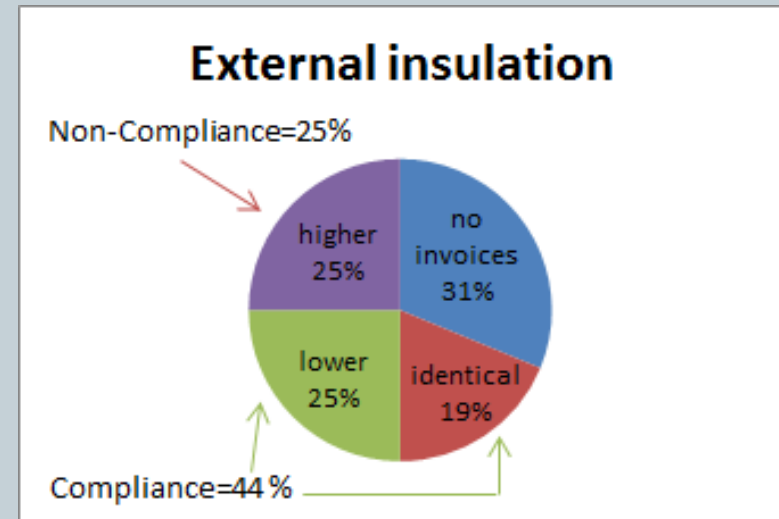
Comparison of the materials' implementation values as reported in the final EPC with the design values

Implementation values higher than the design	Implementation values lower than the design
Range of difference for external insulation U-values	12%	8-23%

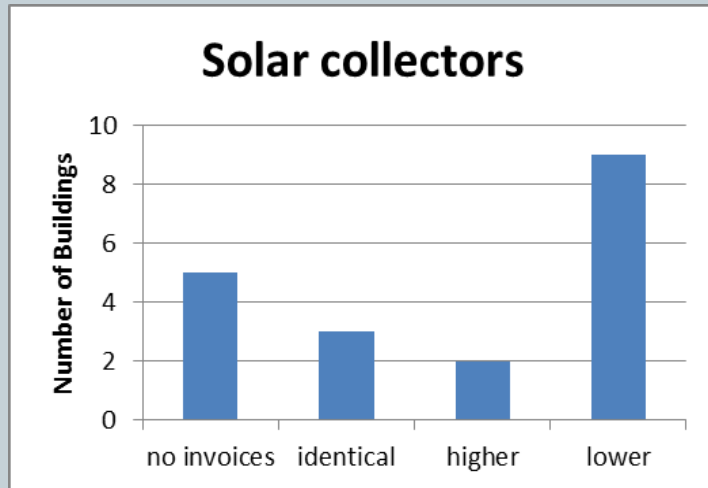
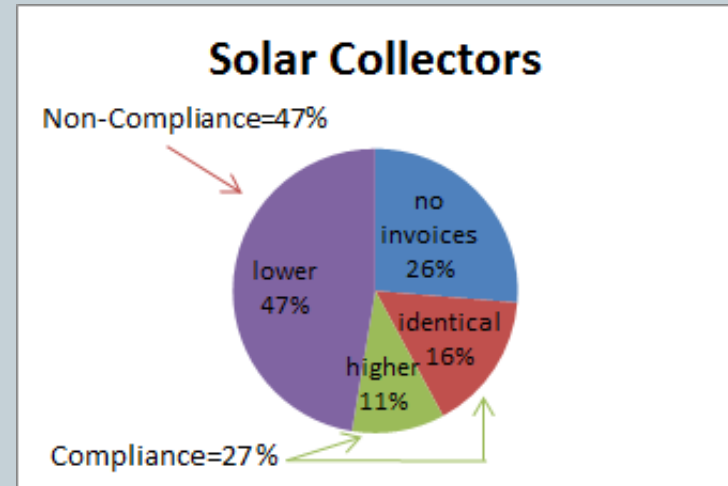
Comparison of the materials' implementation values as reported in the final EPC with the design values

Implementation values higher than the design	Implementation values lower than the design
Range of difference of solar collectors' area	4-15%	5-22%
